National Register of Historic Places Registration Form

historic name Sander, Augustus, House

street & number 408 W. Jefferson Street [N/A] not for publication

Sander, Augustus, House
Benton County, Missouri
Historic Resources of Cole Camp, Missouri

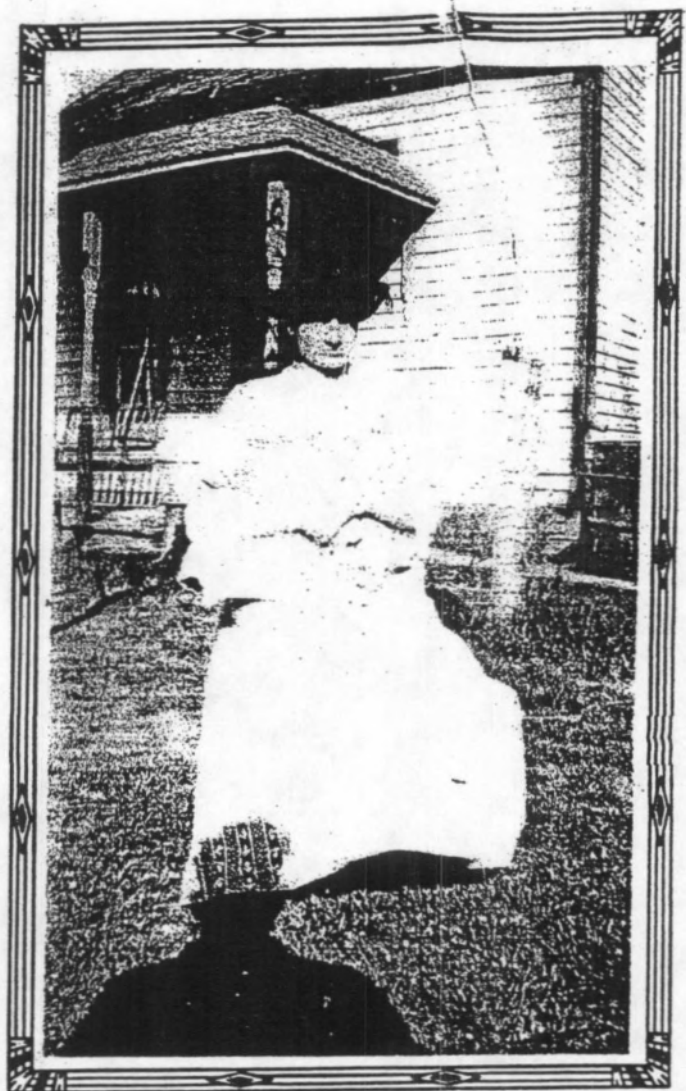
Figure Three. Photo taken of a Brandt family member in the first half of the 1900s. Photo courtesy of Robert Owens.

In 1891, the house came into the ownership of Frederick W. P. Brandt and his family. The house stayed in that family well into the middle of the 20th century, and it was probably under their ownership that it took its present form. The front porch addition may have been their first project. An increase in real estate tax valuation between 1889 and 1894 indicates that some sort of work was done to the house at that time, and the simple Victorian styling of the front porch is typical of houses built in the area in the late 1800s and very early 1900s. It has therefore been assumed that the porch was added ca. 1893.
